## TIE-DOWNS TESTED BY YASI

Tropical Cyclone Yasi passed through Cardwell and the Tully region of North Queensland on February 4, 2011.

By **SUNIL NARSEY**  
Senior State Engineer,  
Mitek Australia Limited

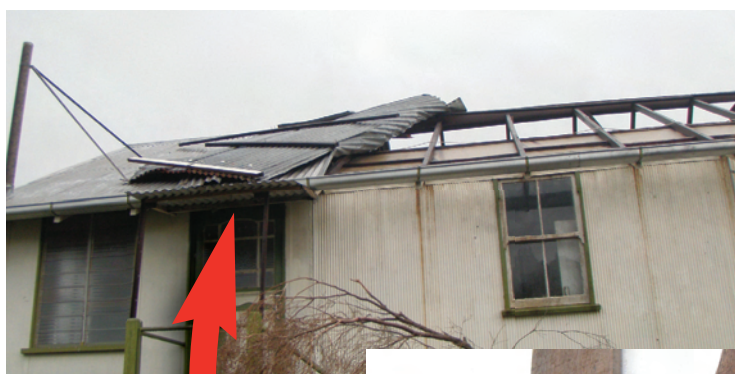
- Loss of roof battens that were fastened to rafters with only one or two plain shank nails. This does not comply with AS1684.3. They would have survived if batten ties were used. This simple failure could have been prevented at minimal cost and accounted for up to 70% of the roof damage caused by Cyclone Yasi.

■ Inadequate batten to rafter fixing.

- all roof framing components, such as rafters and struts must be adequately tied to each other or anchored to the top plate with framing anchors or straps;
- use of robust fasteners, such as batten ties, to ensure correct fixing of battens to rafters;
