BRETT BOLDEN
Fabricator Support
Manager/Engineer

MISSING LINKS IN ROOF BRACING

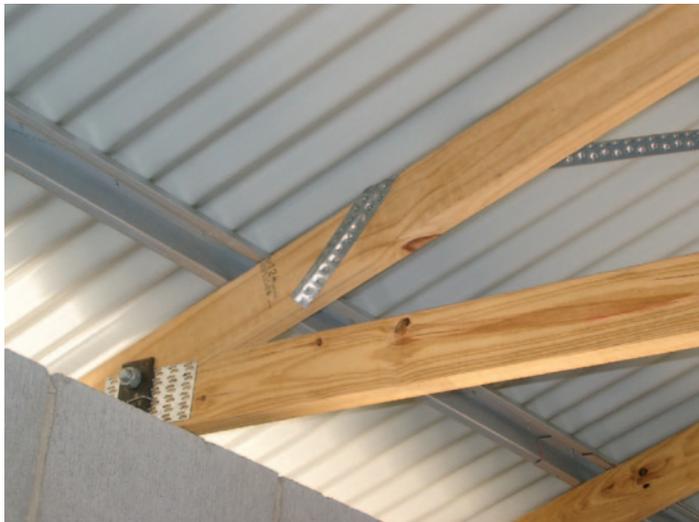
The second area where I occasionally find inadequate bracing is in a cantilevered situation.

The builder either terminates the Speedbrace prematurely on the top chord above the supporting wall (see photo) or bends it down steeply towards

■ Roof bracing not connected to supporting structure.

the top plate at that point. Neither is acceptable.

The former does not transfer forces down to the supporting wall and the latter exerts an excessive lateral force sideways on the truss. The proper method is to extend the Speedbrace right to the cantilevered heel end of the truss and then to brace it back to the top plate at a bottom chord level.

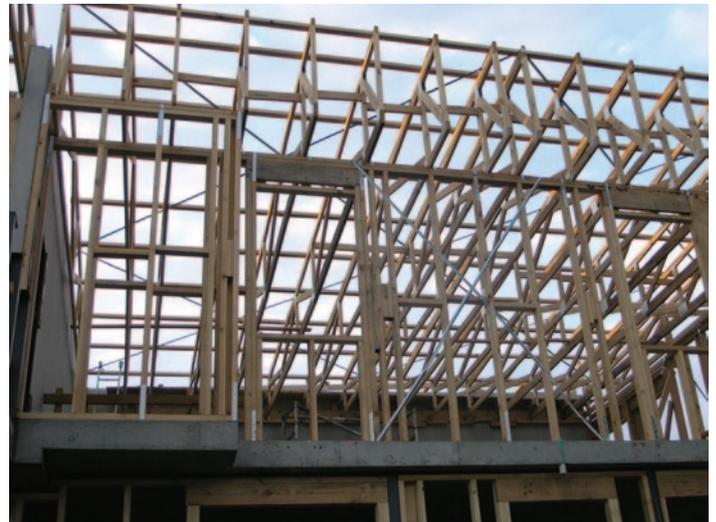
Even if the carpenters do install stock standard bracing on top of their trusses, the trouble is that the bracing forces which accumulate at both ends of the Speedbrace are left to disappear into

■ No connectivity between roof and wall bracing.

fibro sheeting and somehow reappear again at the top plate level.

If I were an anthropologist, I would describe these as the "Missing Links".

required to transfer the roof bracing forces to the bottom of the truss where the supporting structure takes over.

Where Speedbrace is anchored to the apex of a half truss, additional cross bracing on the vertical end face is then
