Continuous Spans - Pitfalls To Avoid (Part 2)

by **ROBERT TAN**

Senior Engineer, MiTek Australia Limited

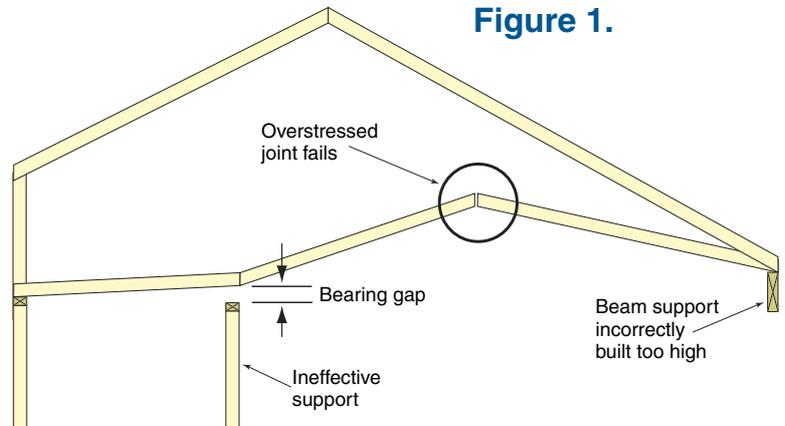
Figure 1 shows an example of a

truss failure I investigated earlier this year. The beam support on the right hand side was deliberately propped higher by about 12mm to allow brick columns to be built underneath at a later date.

Consequently, even though the other two supports were near level, the truss could not bear on the centre support when installed.

When the heavy slate roof was laid, the truss sagged until it reached the internal support. By then, the tension stress on the bottom chord had become much higher than predicted in design.

2. When internally supported trusses are required, drawing notes stressing the importance of level supports beneath them should be added to the truss layout.

In both of the above cases, the use of 'Support Here' stickers would assist to remind both fabricator staff and installers that trusses have been designed with internal supports.

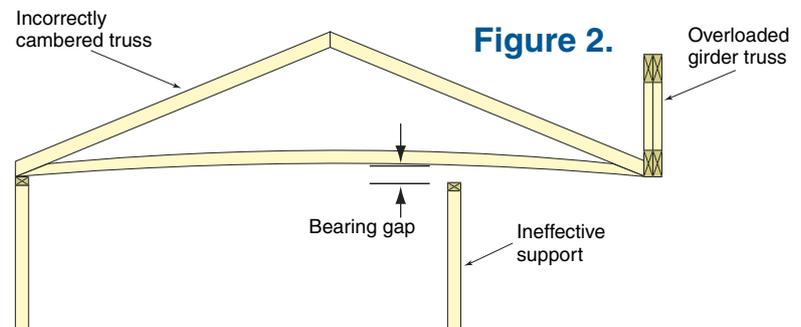
In another example demonstrated by Figure 2, the truss plant operator failed to read the fabrication plans properly

and mistakenly manufactured the trusses with natural camber between the external bearing points.

To make matters worse, the internal wall on site also happened to be marginally low compounding the gap to the bottom chord. As a result, a truncated girder truss on the right supporting a run of these trusses became overloaded and deflected far more than expected.

On investigation, some bottom chord splice plates were also starting to come apart in the overloaded girder.

1. The truss detailer must communicate design assumptions to factory staff and their clients so that all concerned appreciate what needs to be done.

The staff in the truss plant must be trained on the importance of carefully reading and following the cambers in the fabrication sheets.

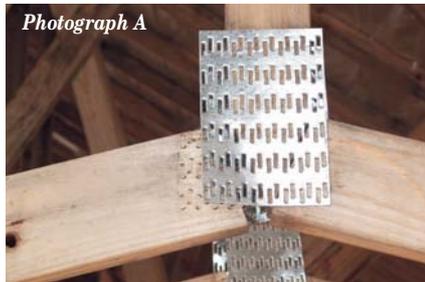
Eventually, this led to all of the bottom chord splice plates in this run of trusses failing at the apex of the cathedral ceiling. See Photograph A.
