ELECTRICAL SUPPLY CABLE DAMAGE

Owners of Mini Titan Mk1 pressing systems manufactured by Mitek Australia (formerly Gang-Nail Australia) and Mitek USA are advised to read this document carefully. It contains important information concerning the control of a potential hazard associated with these presses.

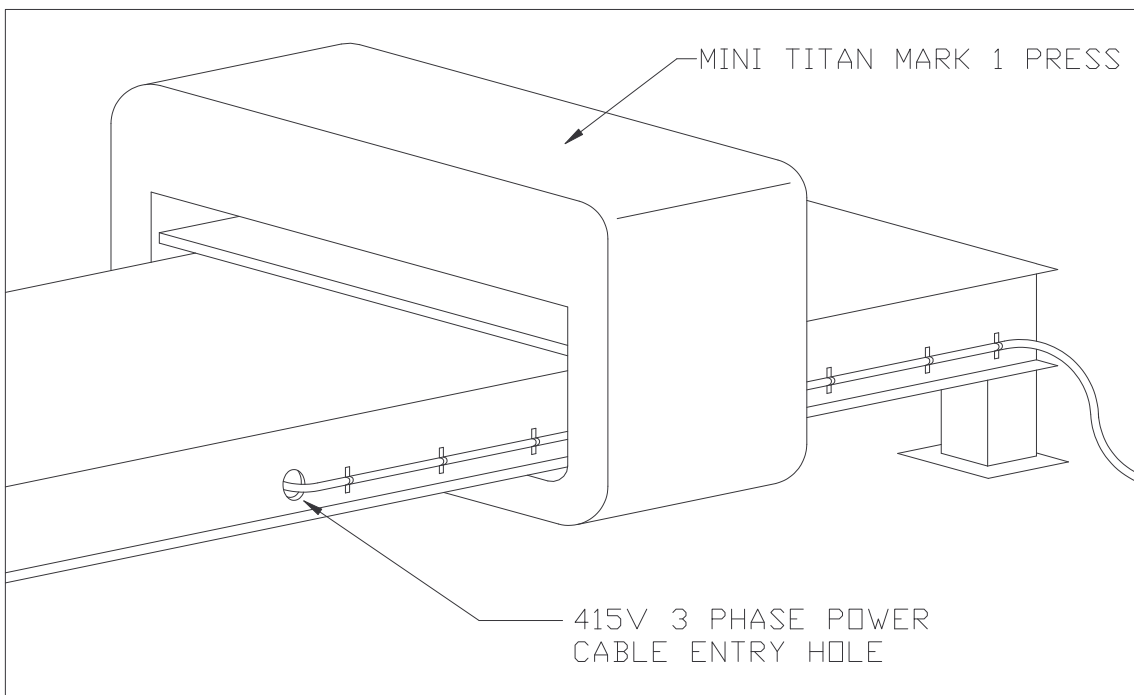
FIGURE 1 - Electrical Power Cable Entry Hole Location

A manufacturing fault may exist in some Mini Titan presses causing the 415V electrical supply cable insulation to be worn away. On some machines the entry hole on the table for the power supply cable is located too high on the I-beam. This causes the electrical drag chain ("caterpillar track") underneath the table to ride over the power supply cable and wear away the insulation, which may result in exposed high voltage wires.

Figure 1 identifies the power cable entry point.

As an alternative to moving the entry hole, install a roller above the hole on the I-beam, so that the drag chain is guided over the cable.
