CUTTING CHAMBER DOOR FAILURE

Truss plant owners operating a Razer Saw manufactured by PFP Technologies P/L and supplied by Mitek Australia Ltd are advised to read this document carefully. It contains important information concerning the control of a potential hazard associated with the Razer Saw

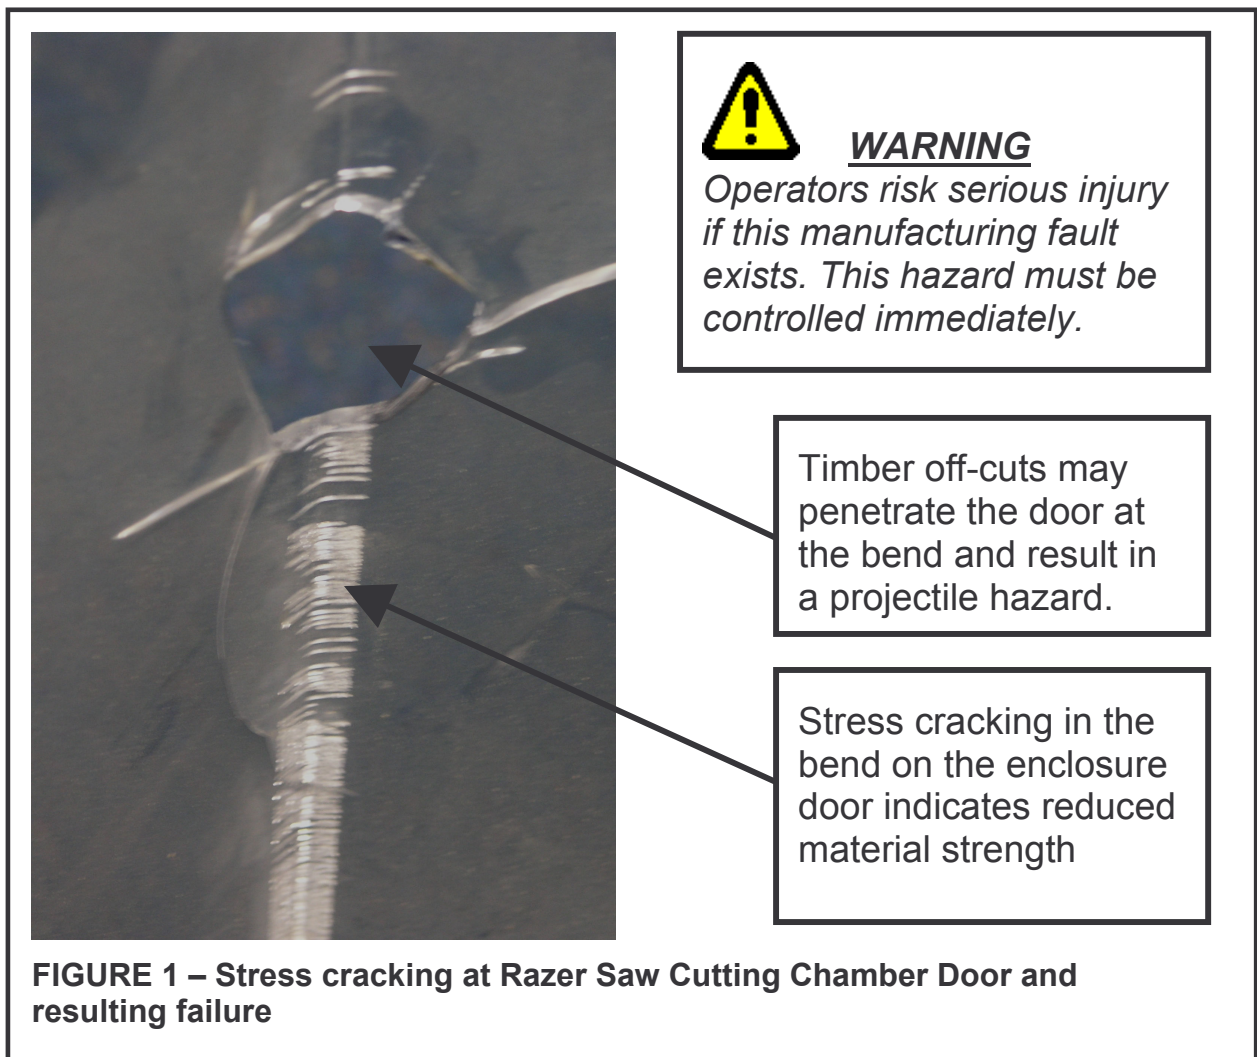
A manufacturing fault may exist in the polycarbonate ('lexan') door to the cutting chamber on the Razer Saw. Stress cracking may appear at the vertical bend in the door, indicating increased brittleness of the material at the bend and reduced capacity to absorb the impact of timber off-cuts.

In some cutting scenarios a timber off-cut has the potential to hit the brittle area at high speed, penetrate the door, and become a dangerous projectile in the factory.

Figure 1 below shows an example of the stress cracking and the resulting material fracture due to the impact of a timber off-cut.

- Immediately inspect the polycarbonate sheet on the door for evidence of stress cracking as pictured in Figure 1. If stress cracks exist, or there is other evidence of reduced material strength at the bend, contact your local Mitek office immediately. Mitek will advise the procedure for rectification of the manufacturing fault..
