# THE ANSWER MY FRIEND . . .

By **TIM ROSSITER**

*Chief Engineer,  
MiTek Australia Limited*

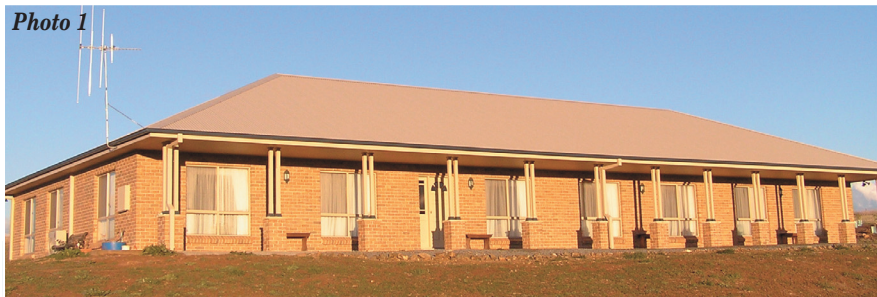
Photo 1

- 1) Before - Garage (the damaged area) is at the right hand end.
- 2) View from windward side of

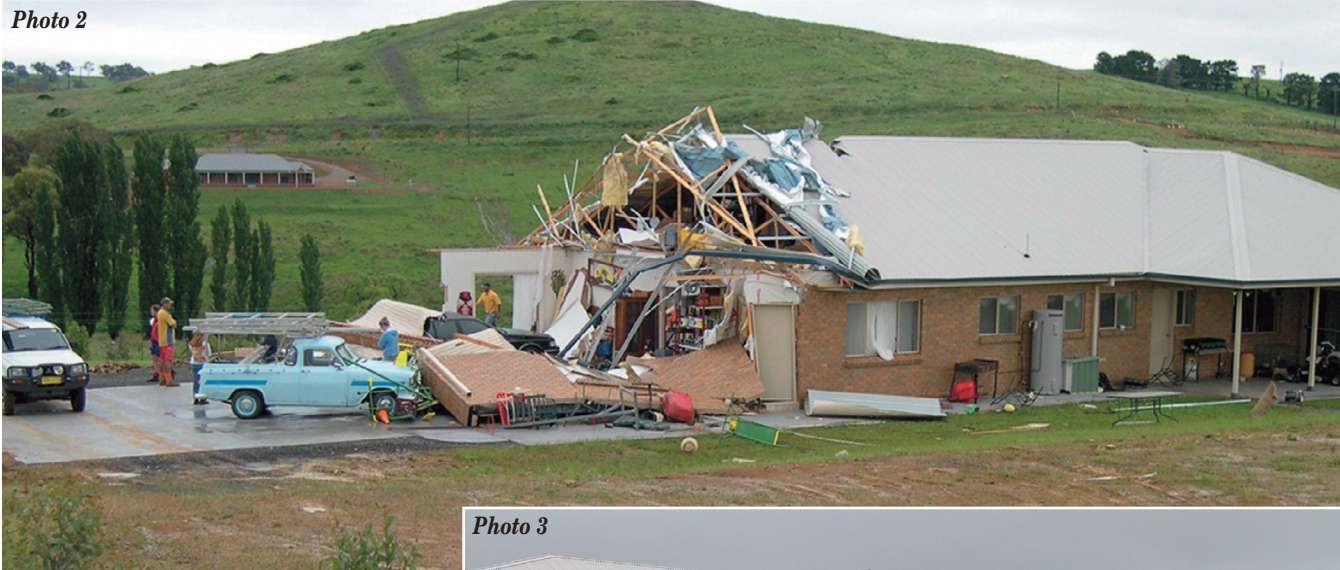
Photo 2

- The owner was in the room next to the garage that can be seen in Photo 2. During the storm, about midnight, the debris (a garage door) shattered the window to that room and the occupant was unable to open the door to the hall due to the wind pressure suddenly created in the room.
- The ute parked in front of the garage was parked at 90 degrees to the garage door before the storm.
- It is brick veneer construction so the force on the brickwork was clearly transferred to the timber frame.
- The houses on properties around
