**TIM ROSSITER**  
Chief Engineer  
New South Wales

## WATCH OUT FOR “ANTI-SPLIT” PLATES!

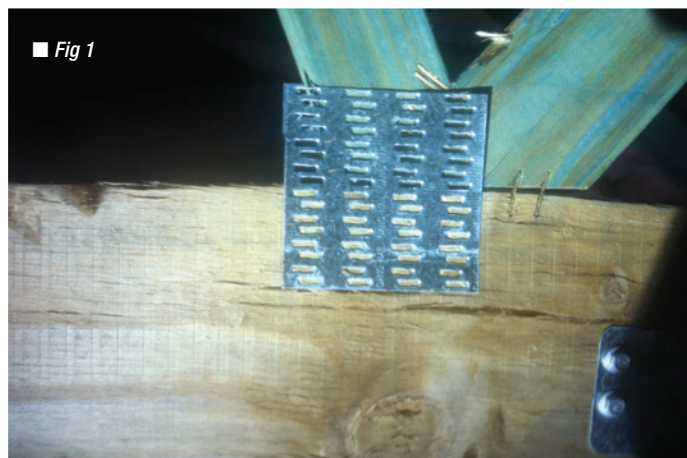
■ Fig 1

Occasionally we see jobs on site where a split has occurred in a girder truss bottom chord, e.g. Fig 1 and 2, and these splits are being unfairly blamed on timber quality.

However, often it is the incorrect application of Anti-Split plates that is the cause of these types of problems – in Fig 1 they are missing and in Fig 2 incorrect location (in the depth on the bottom chord).

It's interesting to note that the situation in Fig 1 occurred quite soon after the job was loaded, but Fig 2 occurred some years after the trusses were installed.

Not only should the anti-split plates be included when required, but they must be located as specified to be effective.

If you suspect that they may have been missed on a job you have already supplied, then contact your nailplate suppliers engineering support asap for remedial work - it will be much cheaper and simpler to fix before a split occurs than after the next big storm!

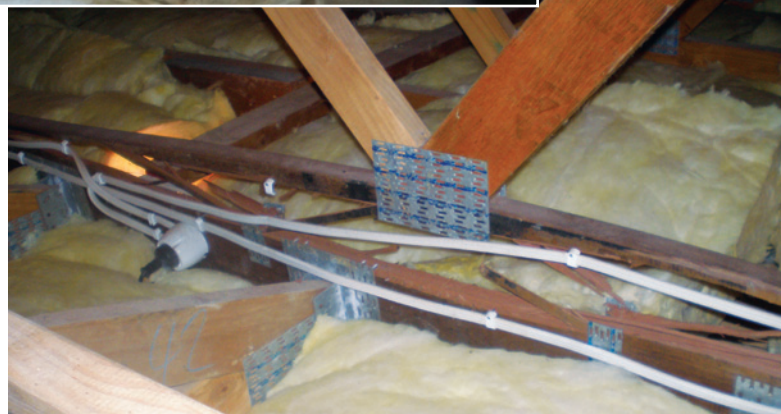
■ Fig 2

In fact the incorrect positioning of the anti-split plate has probably contributed to the instigation of the split – the top of the anti-split lined up with the underside of the web joint plate.

then an extra ordinary event, a storm perhaps, is enough to tip the balance – that was the case of the truss in Fig 2.

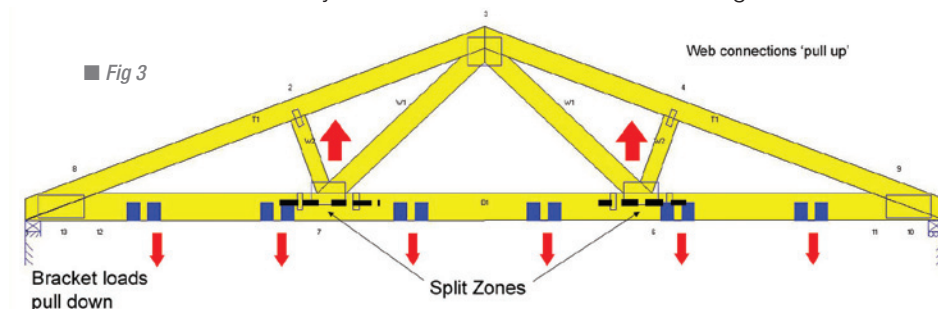
■ Fig 3

The need can be seen in Fig 3, where the load in the bracket pulls the lower part of the bottom chord down, while the webs resist, or “pull up”.

Web connections 'pull up'

Bracket loads pull down

Split Zones

Nailplates that bridge this split zone reinforce the “glue” and provide sufficient strength to prevent the timber from splitting.
