TIM ROSSITER
Chief Engineer
New South Wales

RESTRAINTS ARE KEY TO TRUSS PERFORMANCE

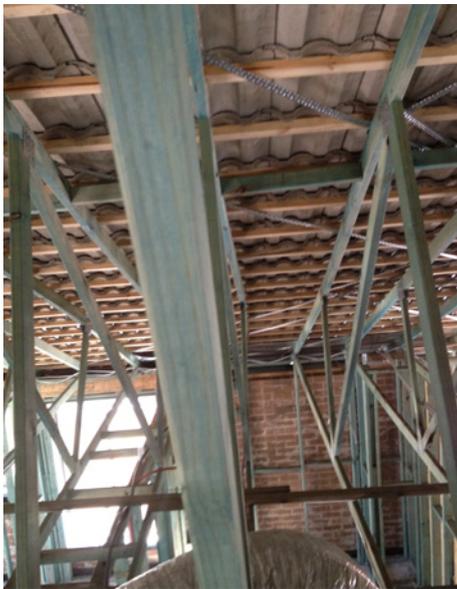
Take Photo 1 for example where the top chord is clearly outside the required limits of straightness.

■ Photo 1: Top chord outside the required limits of straightness.

The roof plane cannot tolerate this level of misalignment without exhibiting waves, which it did have.

Judging by the straightness of the Speedbrace in Photo 1, it is apparent the trusses were installed in this buckled condition.

Notice the nog between the top chords which is located about where the buckling commences; it is likely that insufficient temporary ties were used to ensure these trusses remained straight while the tile battens were installed.

Temporary braces are required at 3m maximum centres along the slope of the top chord.

They may be either full length timbers or proprietary steel truss spacers but not nogs as seen here.

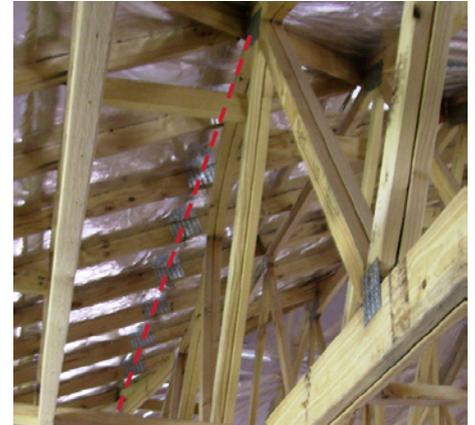
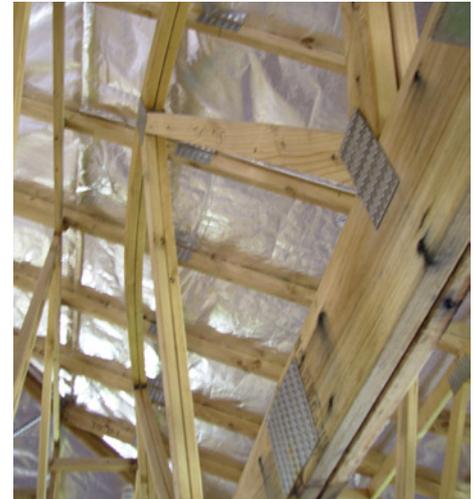
No one noticed the severe buckling in the horizontal top chord (HTC) of the double truncated girder truss above!

The truncated girder in question may be viewed from both sides in Photos 2 and 3.

■ Photos 2 and 3: The buckled truss and truncated girder.

The issue in this case is that there was no positive connection between the over-flying rafters to the HTC to hold it plumb.

In this instance, the framing anchor missing between the rafter and HTC is not so much for holding down the jack trusses; it is rather to restrain the HTC against lateral movement which is essential for the overall performance of the truncated girder.

It is imperative for the installation instructions provided by the truss supplier to be followed in all instances.

For them to stay that way after loading, they must be restrained against lateral movement with adequately close ties and proper connections.
