# GN GUIDELINES

NO.215

## An overloaded floor accident waiting to happen

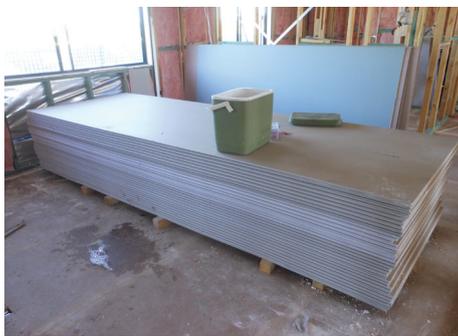
plasterboard stockpile (Image 1) was still on floor trusses even though they were temporarily propped.

Even more worrying was that fact that four plasterers were sitting on the stockpile during their break, adding more load to an already overstressed floor.

The plasterboard stockpile was approximately 6.0 m long, 1.2 m wide and 0.8 m deep. This equated to a superimposed load of 5.5 kilopascal (KPa), which is about three times the 1.5 KPa design standard for a live load on domestic floors.

Image 1: Plasterboard stockpile overloading the floor.

The floor installation manual, as supplied by the nailplate supplier, stipulates that a temporary stack of sheet materials on floors should not be greater than 300 mm deep or exceed 250 kg/m<sup>2</sup>.

As always, prevention is better than cure – and installers should be fully aware of the floor loading requirements as set out in the installation manual, particularly concerning handling and storage.

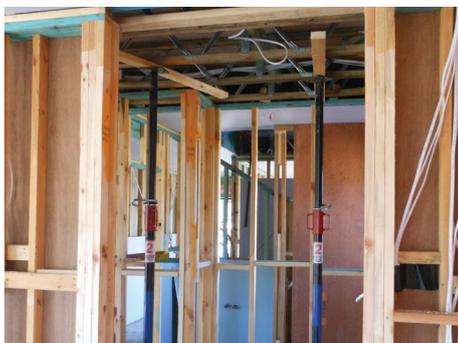
Image 2: The danger area was not closed off with any signs or barriers.

As a safety precaution, the site supervisor should have closed off the damaged zone with tapes or barriers on both the ground and first floors of the area in question, as well as posting appropriate 'Caution: No Access' signage (Image 2).

We should be preventing entry to any location where there is a potential for collapse at all times.

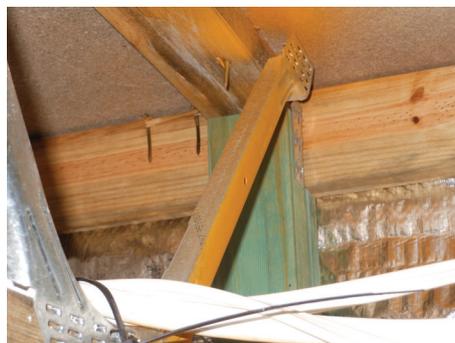
Although I observed no deflection under the floor trusses because of the temporary propping, judging by the condition of the metal webs, they must have been sagging much earlier.

The webs in this case were completely dislodged and twisted at the support points.

Image 3: Overloading caused the webs to dislodge.

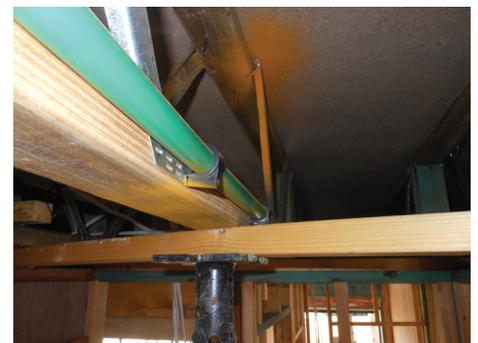
Additionally, the props were not secured with nails or screws and neither was the spreader plank underneath the floor trusses. With the plasterboard stockpile still loading the floor trusses, any slight movement would see the props slide out and a subsequent collapse of the floor.

Image 4: Neither prop nor timber plank were securely fixed.
