By Stuart Branch – State Engineer NSW

Sawn timber characteristics and roof truss construction

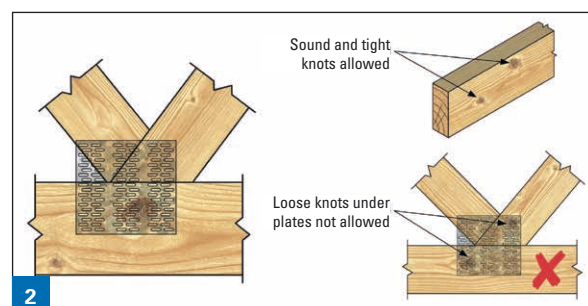
Not that long ago I was asked to prepare a remediation/rectification detail for the broken bottom chord segment shown in the photo (above right).

My first line of thought was “surely this piece of timber isn’t of structural grade considering the extent of the knot present.” Consulting with the truss plant manager it was confirmed it was of structural grade and had been graded MGP10 by the timber supplier.” The next question I asked the plant manager – should it have been used for truss construction? – was met with a resounding “no.”

Sawn timber, if managed properly, is a strong, lightweight, cost-effective building material which is purpose-built for building timber structures. It is recommended that all timber quality control concerns be directed back to the timber supplier for further assessment. **T**
