GOOD NEWS AND BAD NEWS

by **TIM ROSSITER**
 Chief Engineer,
 MiTek Australia Limited

The subject of this article is about a site inspection that I did some months ago.

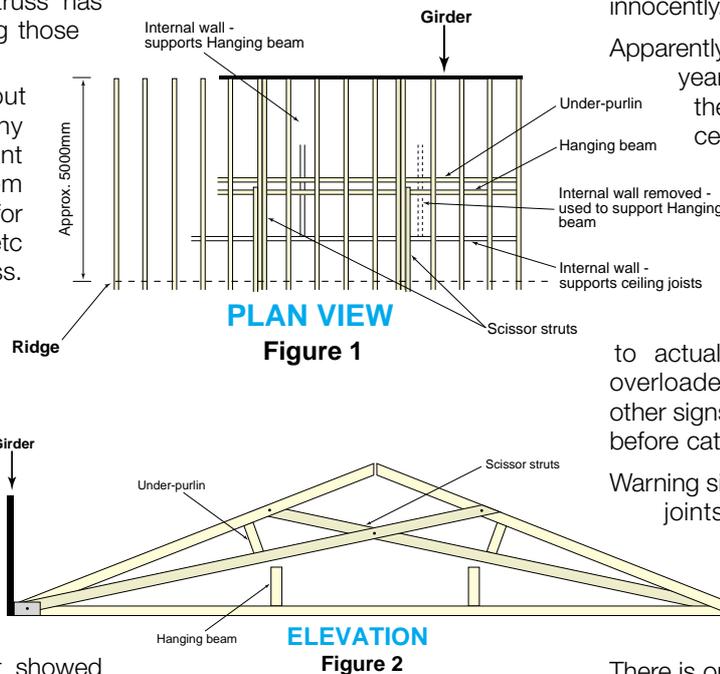
When I arrived I was shown the family room, where a rather unattractive prop was positioned beneath a dramatic crack in the ceiling that extended to the now deformed cornices at either end, seemingly due to an overload from the truss above - hmm!

Crawling into the roof I found that - yes - this was a conventional roof and - yes - the webs had separated from the apex joint. In fact I was quite glad that the girder was propped.

struts, which in turn were supported by the now failed girder truss.

To make matters worse, the internal wall shown was removed and the hanging beam was then 'hung' from the rafters above. So the girder truss was really supporting approximately 10m of roof applied as two large point loads, plus the extra ceiling load from the hanging beam support.

Figure 1 shows a sketch of the plan view of the problem area and Figure 2 shows elevation of the real culprit - scissor struts!

In this case the rafters were supported on the under-purlins, and the under-purlins were supported on the scissor

For the record the solution in this case was to insert another truss beside the existing girder creating a double truss strong enough to carry the entire 10m of roof load.
