**TIM ROSSITER**  
Chief Engineer NSW

## 'GET THEM TO STOP IT'

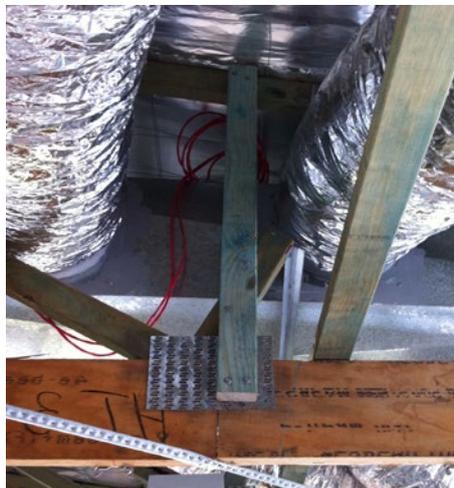
Take the truss in Photo 1 for example. A web was cut to fix flexible ducting and a vertical strut was screwed into position in a poor attempt to compensate. Note:

1. Trusses work because they are made up of triangles. Webs (sometimes incorrectly referred to as "internal struts") join the top and bottom members (chords) to form a series of triangles. The triangles are what hold the truss in shape. Without them, the truss shape will flop about.

2. The strength of a nailplate is very high and not easily substituted by nails/screws/bolts in the compact area it occupies.

3. The positioning of nails/screws/bolts is critical to achieving its full strength; the minimum distances to timber ends and edges (which vary with each fixing type and size) must be maintained.

■ Photo 1: Could the ducting not have been moved over a little?

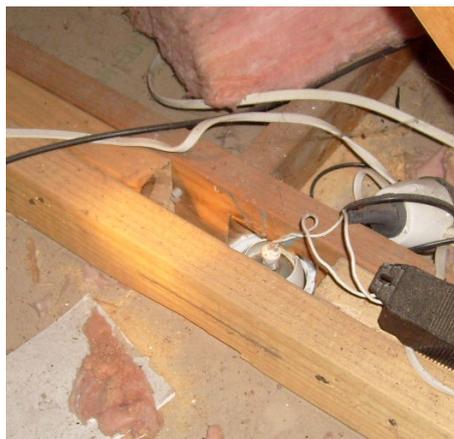
In Photo 2, a bottom chord was cut to fit a down-light. Note:

1. It is the outer perimeter of a truss (chords) which does the most work and because they are heavily loaded they

are normally made with high strength materials.

2. It is also the outer perimeter of a truss which controls truss deflection. If their continuity is broken, you can expect a significant increase in deflection.

3. The amount of tension force pulling apart the bottom chord is quite substantial – even more so when it is carrying other trusses, as was the case in this truncated girder.

■ Photo 2: Could the down light not have been repositioned?

4. When a tension member is cut, the gap quickly separates and opens up, and not only is deflection inevitable, other components are also forced to pick up the extra load and the entire truss performance is compromised.

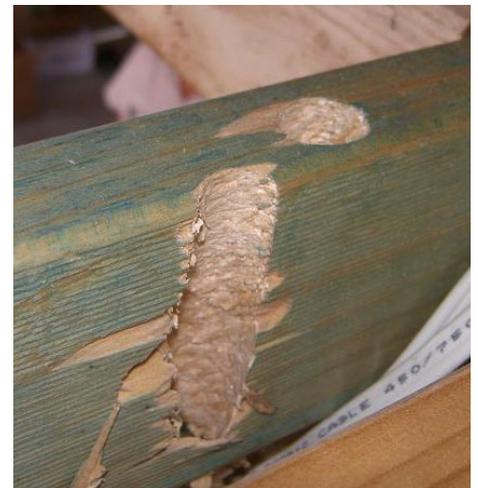
Is there really anything I need to say about Photo 3!?!?

■ Photo 3: Is this a case of cut first and ask questions later?

All it takes is a little effort to reposition the services and these modifications would have been avoided.

Secondly, when an alteration is required, it is vital to get the appropriate rectification details before cutting or drilling anything.
