By Tim Rossiter, state manager, NSW and WA

## When acceptable deflections are unacceptable

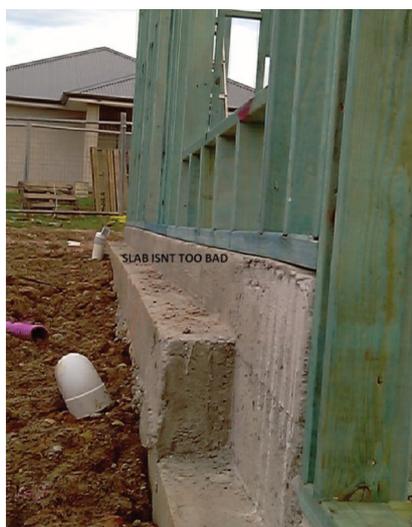
Figure 1

The request from the supervisor was accompanied by a photograph of the slab below the wall in question, with a note inserted stating that the "Slab isn't too bad" (Figure 1).

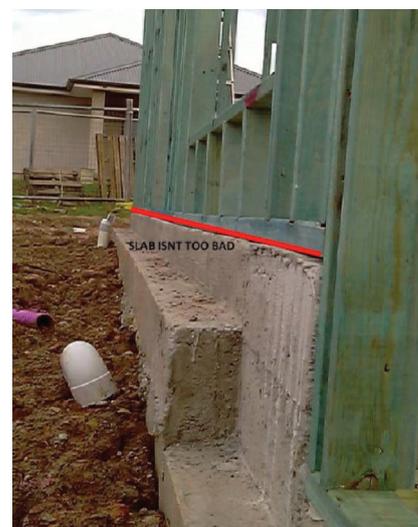
In Figure 2 I added a straight line for guidance – you be the judge. The hump in

the bottom plate should have been sufficient indication of a problem in the slab leading to a problem in the ceiling.
