STOP YOUR GIRDERS DOING “THE TWIST”

by **TIM ROSSITER**

Chief Engineer, MiTek Australia Limited

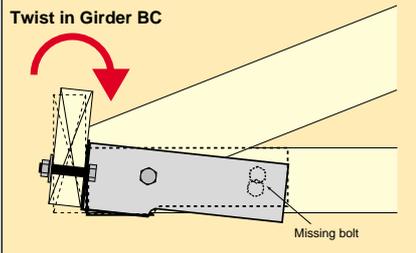
An exaggerated example of a twisted bottom chord due to incorrect bolting of the supported truss..

Note the following:

- The carried truss is below the level of the girder truss
- The bracket is protruding into the ceiling lining.
- The gap that has been allowed to form between the carried truss and the face of the girder is caused by a loose bracket.

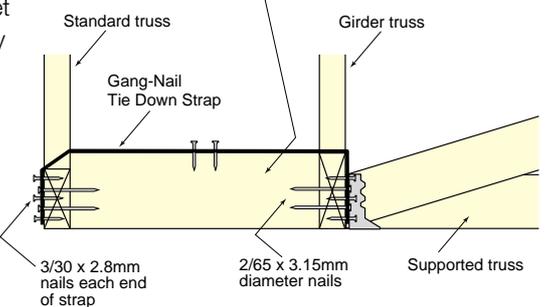
Anti Rotation measures for Joist Hangers

There are some brackets, such as Joist Hangers, that require anti-twist measures that allow the bracket to achieve the full load capacity specified in the manufacturer’s literature.

It is important that these anti-twist measures be carried out **when the bracket is first installed.** It has been found

Nogging same depth as girder truss bottom chord
