GN GUIDELINES

By Tim Rossiter, Chief Engineer NSW

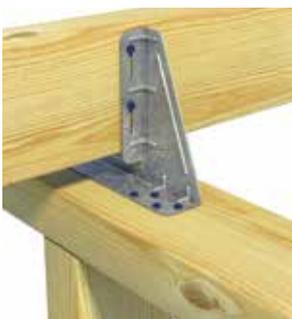
Image 1.

IWBs are not sheer connections for bracing walls. For that application, timber shear blocks fixed in accordance with AS1684 (refer to GN Guideline 137) may be used or, alternatively, the BraceWall Bracket

(Image 1), is a much simpler and more elegant solution.

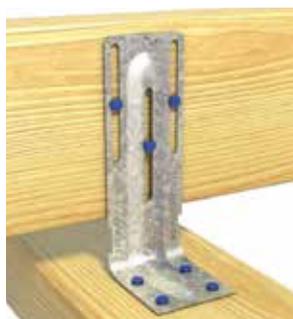
Image 2.

As IWBs are installed before the roof is loaded, allowance has to be made for truss cambers to settle. That is why IWBs have slotted holes to let the nails slide vertically as required. Newer versions of IWBs have longer slots to allow for the rise and fall of heaving slabs (Image 2).

Nails should be fixed at either the top of short slots, or the centre of extra-long slots, which also have markings to assist nail location. They must never be nailed home hard, and never driven in with a nail gun.

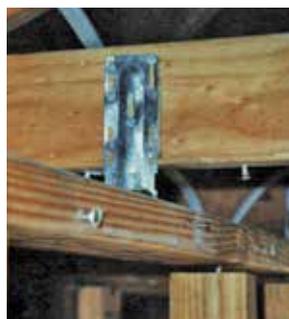
Image 3.

Scene 1 – Nails fixed at the bottom of slots, or locked in with a power nailer (Image 3).

In this scenario, the nails clearly cannot move down, which sets the truss with a permanent camber. However, the trusses beside it do not have IWB fixing, and this

will settle with time. The alternating fixings with and without IWBs then result in a wavy, cornice line.

Unfortunately, this isn't noticed until weeks after the house has been handed over as the trusses creep down. Enter: expensive and time consuming repairs such as, engineering inspection, cornice removal, bracket release, waiting period, bracket re-fixing, cornice replacement and repainting.
