By Brett Bolden, North Queensland Area Manager

The ever humble internal wall bracket

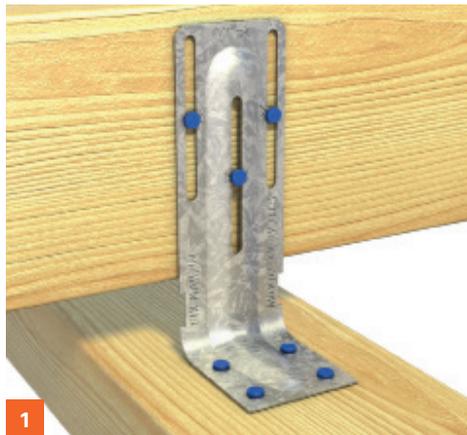
Traditional IWBs should be loosely nailed at the top of each slotted hole to permit downward settlement of truss camber. In the modern version, further elongated slots are provided for the nails to be loosely fixed in the middle (Image 1) to accommodate reverse upheaval of slab edges from reactive soils. If uncertain, always follow the simple instructions stamped onto the brackets. The nails in the slots must be hand driven to allow free vertical movement of the truss up and down the bracket.

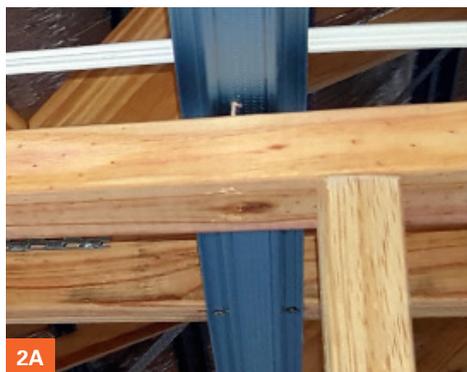
Image 2A shows two nails shot from below the top plate into the metal batten above. If a stud should be in the way (Image 2B), the nails are shot even higher into the feet of the metal batten. These defective fixings count on unreliable bending of nails on thin metal to hold the wall straight, and the greater the gap below trusses with large cambers, the weaker the connection; whereas the smaller the gap, the more likely

the battens will rest and bend over the wall causing ceiling and cornice cracking issues.
