# IMPORTANCE OF TILE INSTALLATION

by **TIM ROSSITER**  
Chief Engineer,  
MiTek Australia Limited

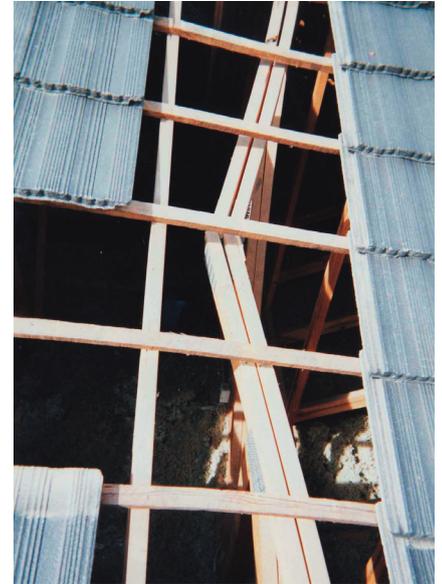
As illustrated clearly in the photograph (see *photo*) - the top chord of the girder truss is severely buckled to one side due to lack of restraint from the tile batten.

The photograph shows a two ply girder truss which has buckled sideways resulting in the bottom chord deflecting downwards.

reported as "failed" only to find on inspection that the top chord has buckled - allowing the bottom chord to drop down. One of the common causes of buckling of girder top chords is the ineffective nailing of battens.
