Loose Upper Pivot Point Bolt

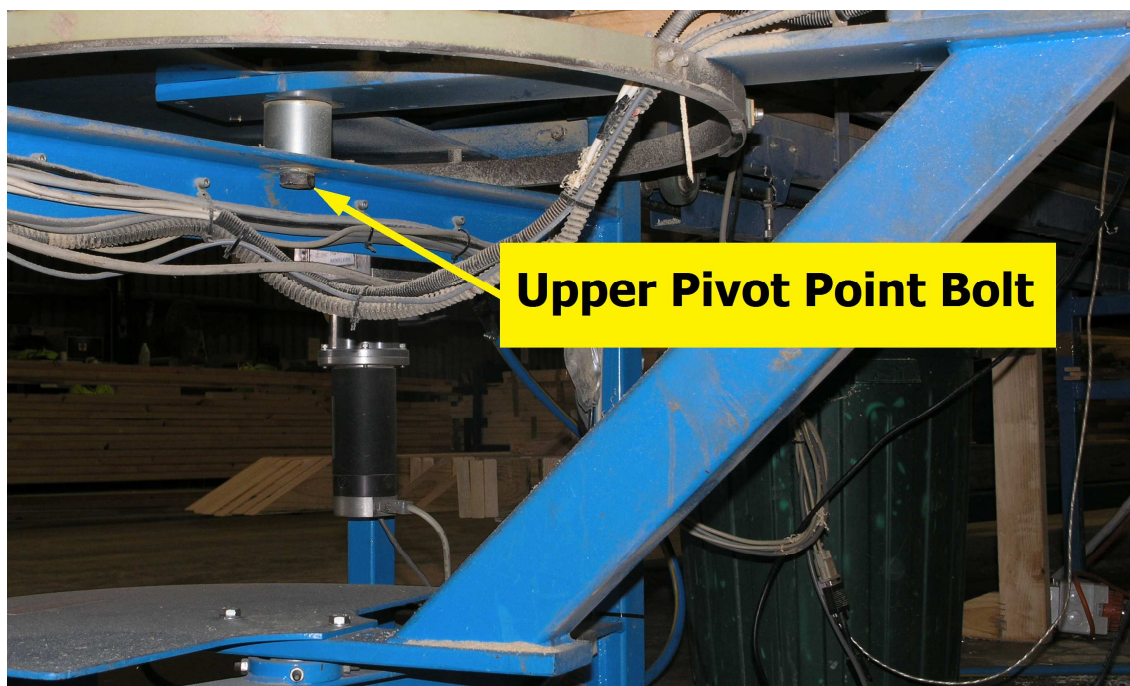
A single bolt secures the upper pivot point of the rotating 'angulation' assembly on the Spida CXM Saw. If this bolt loosens and falls out during operation the saw blade and pivoting arm assembly could lurch forward or backward resulting in risk of serious injury.

The bolt is located on the under-side of the steel cross-member below the rear of the bench top, and secures the upper pivot point for the entire rotating saw assembly. Refer picture below.

MiTek recommends that adequate control measures, including regular maintenance checks, are employed to ensure that this bolt remains tightly fastened. Consult the saw manufacturer if you require further advice.

Owners of Spida CXM and similar model saws should implement the above-mentioned control measure immediately.
