PATRICK GRANDON
State Engineer, Victoria

INTERNAL LOADBEARING GHOSTS

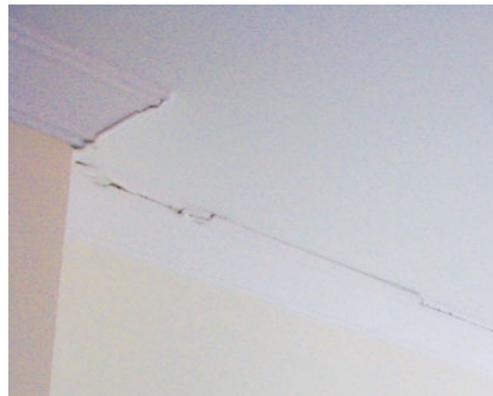
■ Photo 1:
Cornices crushed under each truss.

structural drawings indicated an internal loadbearing wall that, for some unknown reason, was built as a non-loadbearing wall instead.

As a result, outer wall lintels were overloaded and trusses deflected where they were expecting an internal support. This was what led to the cornices being crushed at regular intervals under each truss as shown in Photo 1.

The bottom line is this: Always follow the engineer's drawings to the letter, particularly where internal loadbearing walls, truss orientations and girder locations are shown.

Consult the builder or building designer before making any variations to the construction drawings. To not do so is likely to bring you trouble.

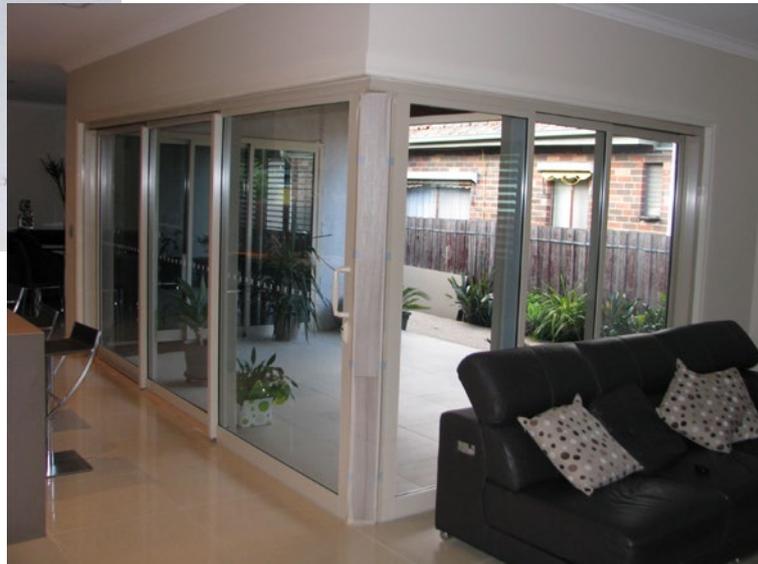
The trusses over an al fresco area were meant to be supported by a wall to the outdoor space (Photo 2).

However, the builder omitted to install a corner post to support the header above the sliding door. As a result, the sliding door jammed, the al fresco veranda beam was overloaded, the ceiling cracked and the roof above the area dipped.

■ Photo 2: A corner post to support the header was missing.

installed in the middle of the kitchen and living area for a period of time which created a nuisance for the occupants and added to an already large repair bill.

Several temporary props had to be
