ENSURING STRONG JOINTS

by **TIM ROSSITER**
Chief Engineer,
MiTek Australia Limited

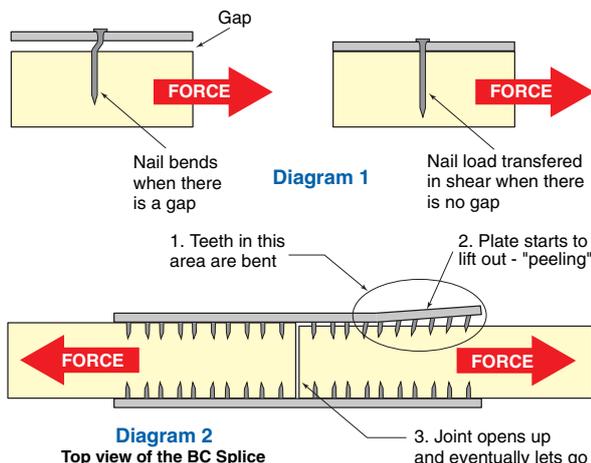
the members being joined, the nail transferring the load to the lower member is allowed to bend, which is weaker than if the load was transferred in shear. (See Diagram 1)

If a gap exists the plate performs in a similar manner to the nail in Diagram 1. That is, the teeth slowly start to bend which causes them to start to pull out of the timber, allowing more of the tooth to be exposed and allowing more bending, etc.

The use of timber with different thickness in the one truss was the cause of a number of BC splices failures in a house I inspected last year. In that case the timber varied up to three mm in thickness resulting in the sequence of events set out in Diagram 2.
