By Craig Klinge, Design Engineer/Fabricator Support Manager

Tension perpendicular: the evil of all wood connections

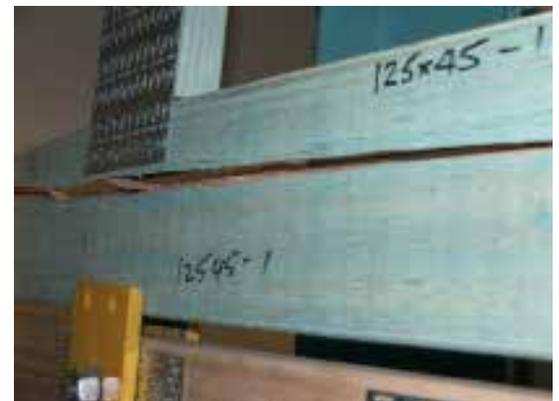
Figure 2: Tension perpendicular failure

Figure 2 shows a tension perpendicular failure which occurred under test conditions when there was only a 45mm bite depth into a 140mm bottom chord. Should this occur to a real truss on site it could result in catastrophic failure to the roof structure. According to Hanson and Eva (2011), 11 percent of building failures which occurred in Germany during heavy snow in the winter of 2005/2006 were attributed to tension perpendicular to grain failure.
