ON-SITE ADJUSTMENTS OF TRUSSES

by **TIM ROSSITER**
Chief Engineer,
MiTek Australia Limited

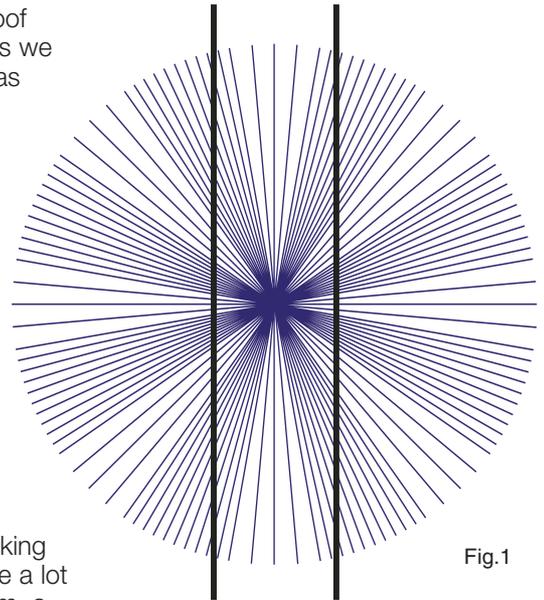
Fig.1

For example are the two vertical lines shown in Figure 1 parallel or bent? Get out a ruler – you might be surprised!

Imagine now that you are looking at some truss member but have a lot of angled members behind them, a similar optical illusion can occur. The best way to check if a truss is deflecting is to use either a string line or a laser level and use the truss support as the datum.
