ANOTHER MITEK ADVANTAGE

ROOF BRACING INTEGRITY

By **DEAN ASHTON**

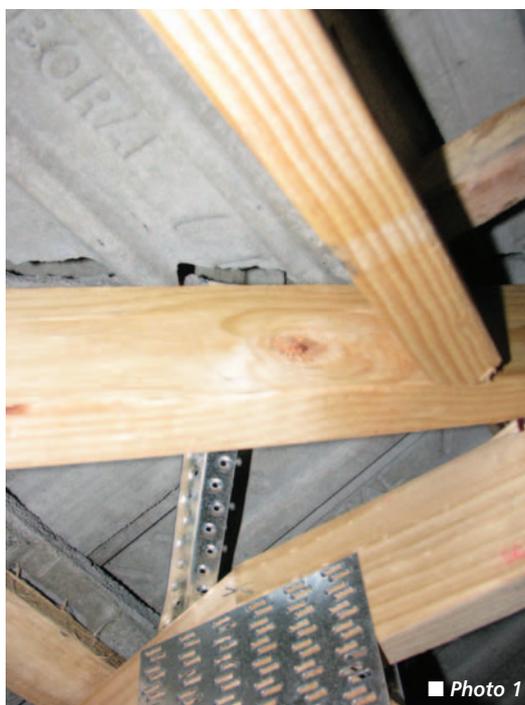
Photo 1

By contrast, photo 1 illustrates an avoidable practice of not wrapping the brace around the truss top chord.

Speed brace should be wrapped around the truss top chord at the apex and be nailed to both the back face and top edge of the truss top chord.

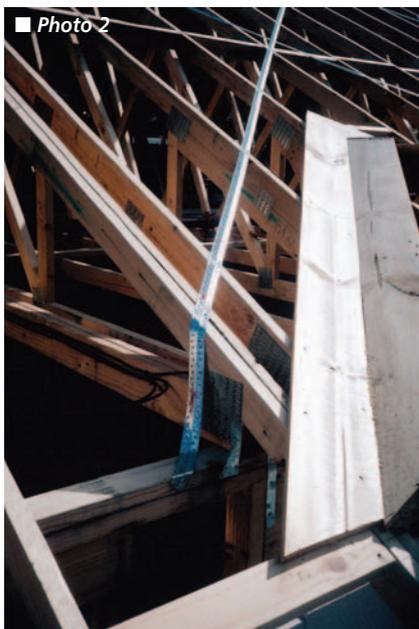
Photo 2 shows an example of speed brace loosely bent at too steep an angle to the top plate and not securely fixed to the side or underside of the top chord, but on top. In tension, the nails will easily pull out and release the speed brace.

At the other end speed brace should normally be securely fixed to the supporting structure by bending the brace down at a gentle angle (less than 45 degrees), nailed to the side of the top plate, then wrapped under the top plate and nailed to the underside.

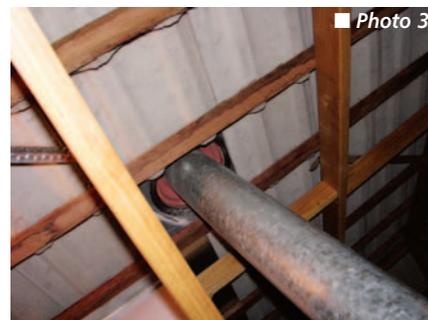
Photo 3 illustrates a situation where the speed brace has been carelessly cut to accommodate a flue without any reinforcement or repair.
