ANOTHER MITEK ADVANTAGE

BRACKETS BEFITTING A LEVEL CEILING

By **TIM ROSSITER**
Chief Engineer,
Mitek Australia Limited

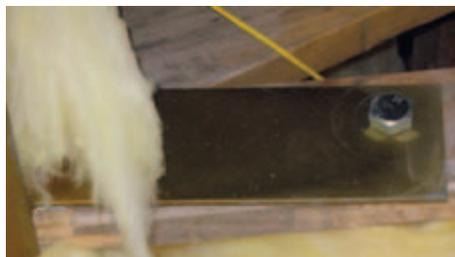
Figure 1 shows a bracket that was located and fitted below the bottom of the girder. The dip was made even worse by fixing it to the truss whilst the bracket was badly rotated, probably caused by the big gap between truss and girder.

As a result, one builder belatedly installed ceiling battens as a fix up solution to compensate for a badly uneven ceiling.

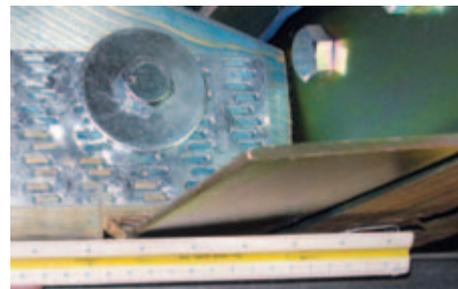
Figure 2 shows a badly rotated bracket where the bolts were not correctly fitted in the anti-rotation flange early enough. Rotation of girder bottom chords and hence brackets can be instigated simply by the self weight of the carried trusses.

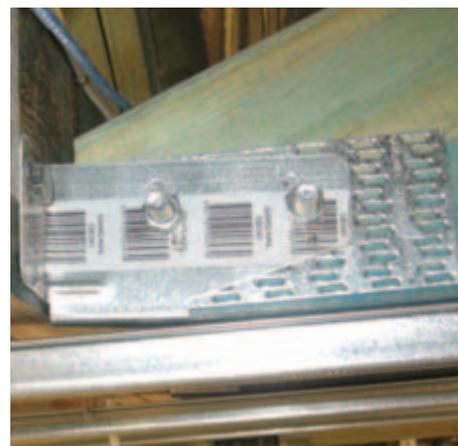
Figure 3 shows an excessive notch, well over 10mm deep into the truss. The cut might have been even deeper had

the nailplate not been there to deter the saw blade!
