STUART BRANCH
State Engineer, NSW

PLAN FOR AIR CONDITIONING!

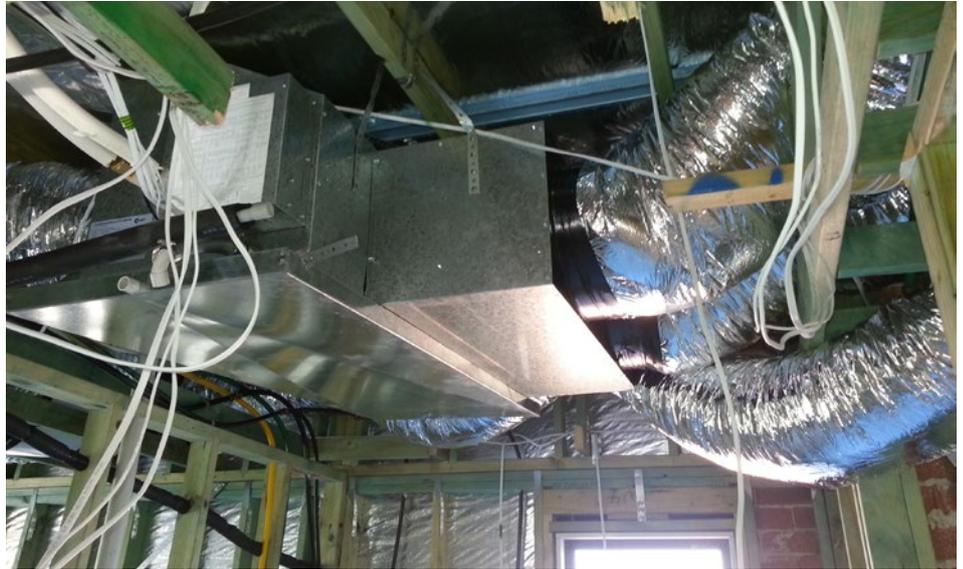
■ A poorly retro-fitted air conditioning unit.

The dimensions of an indoor fan unit (typically around 0.4m high x 1.5m long x 0.9m wide) are usually too big to fit between 600mm standard truss spacing and too large to fit within normal web layouts in shallow roof trusses.

This means that some unfortunate trusses have to have their infringing webs removed.

As soon as that happens, the trusses lose some of their load carry capacity and stiffness, resulting in a localised structural weakness being created within the roof.

Option 1: Strengthening the air conditioning truss and adjacent trusses to carry the increased loading. They may also require stiffening to limit deflections within reasonable levels.

Strengthening details typically involve fixing new web members and/or scab members, inserting hanging beams and reinforcing truss joints with NailonPlates.
