## METAL BATTENS ON TIMBER TRUSSES

by **ROBERT TAN**  
Senior Engineer,  
MiTek Australia Limited

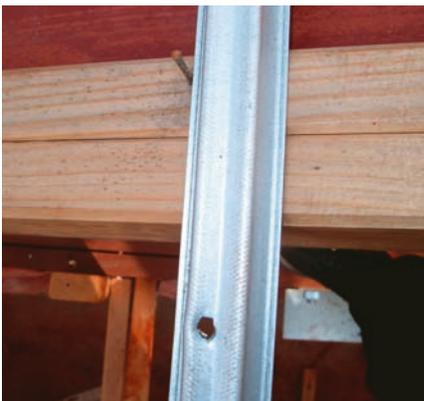
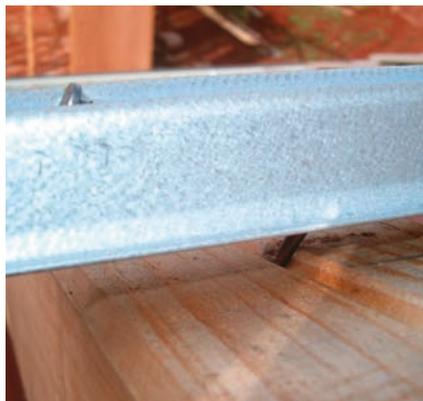
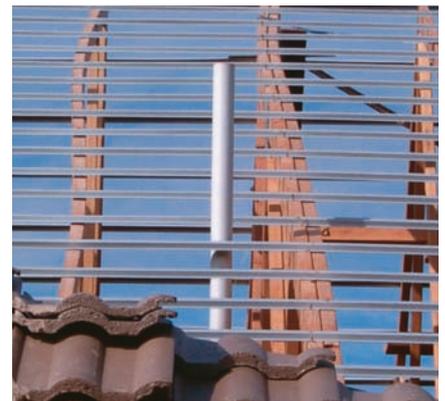
The photographs show examples of poor fixing that resulted in dramatic failure and buckling of the truss chords.

- a. The batten must be fixed directly to the truss through both flanges at the base. Fasteners through the top of the cap section can easily tear the steel batten under lateral shear loads.
- b. The fasteners on the flanges must be flat head nails or hex head

- c. The head of the fixing must hold the metal flange firmly against the timber face. It must neither be too loose nor over-driven, either of which can lead to premature tearing of the metal section under load.
- d. With multi-ply trusses the fixing must be repeated on each ply, and not just applied only to one ply, or worst still into gaps in between.
- e. If required, battens should be spliced with common fixings through both overlapping members onto the truss.
- f. Clipped-on furring channels for ceilings do not provide bottom chord restraint making supplementary bracing necessary. Supplementary bottom chord bracing details can be found in section 4.4.3 of the code AS4440 "Installation of nailplated timber trusses".
